Ice/Frost/Debris Assessment For Space Shuttle Mission STS-32 (61-C)

January 20, 1986

Charles G. Stevenson
Gregory N. Katnik
The John F. Kennedy Space Center, NASA
and Robert F. Speece
Lockheed Space Operations Company
Kennedy Space Center, Florida

ICE/FROST/DEBRIS ASSESSMENT
FOR
STS-32 (61-C)
LAUNCHED
JANUARY 12, 1986

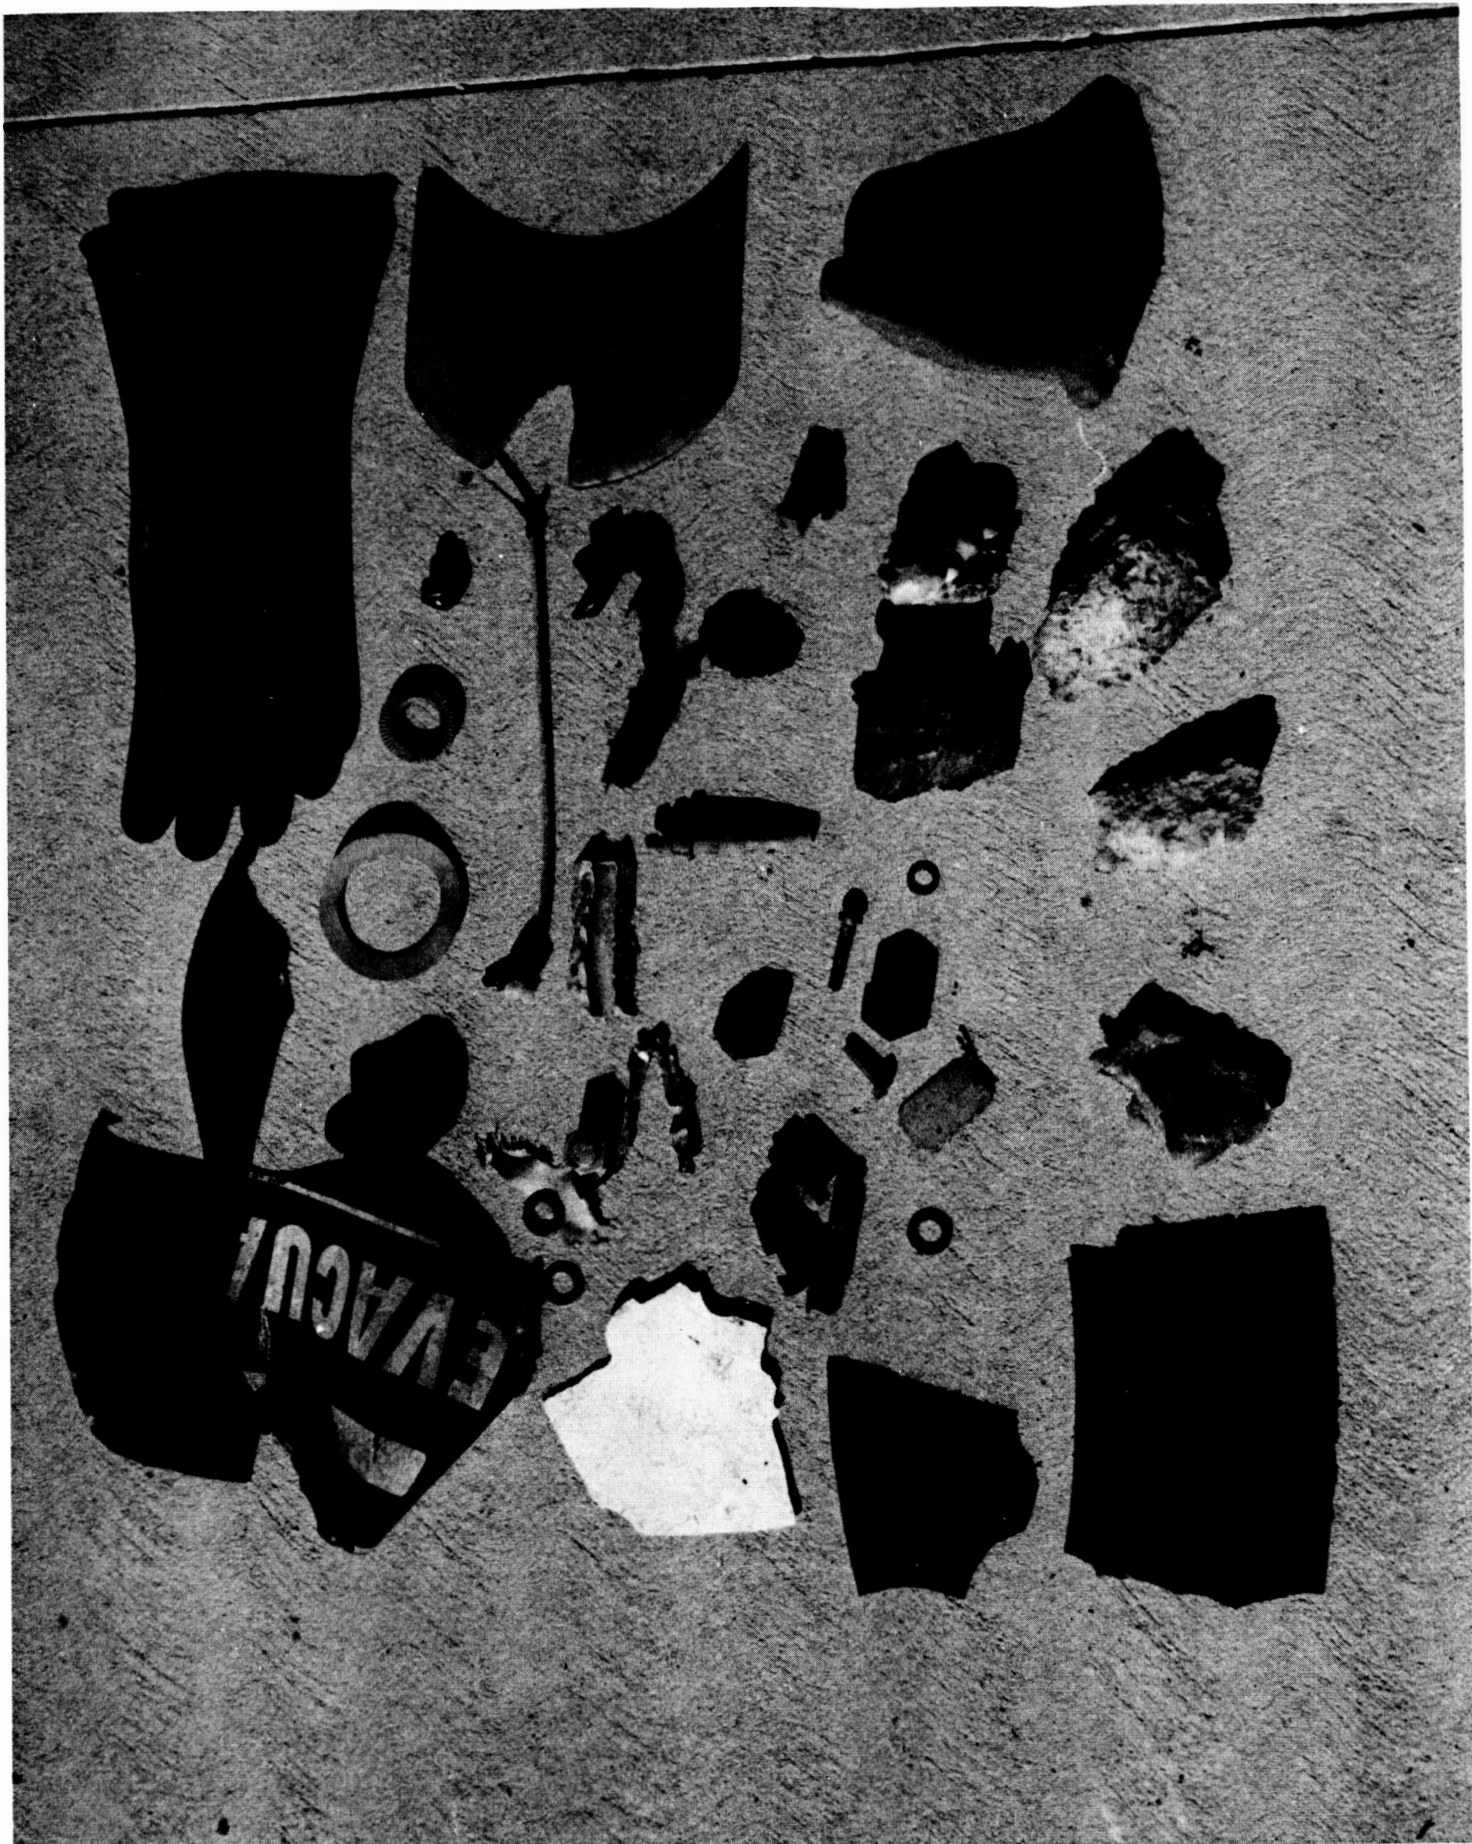
Post Launch Pad Inspection - typical facility debris

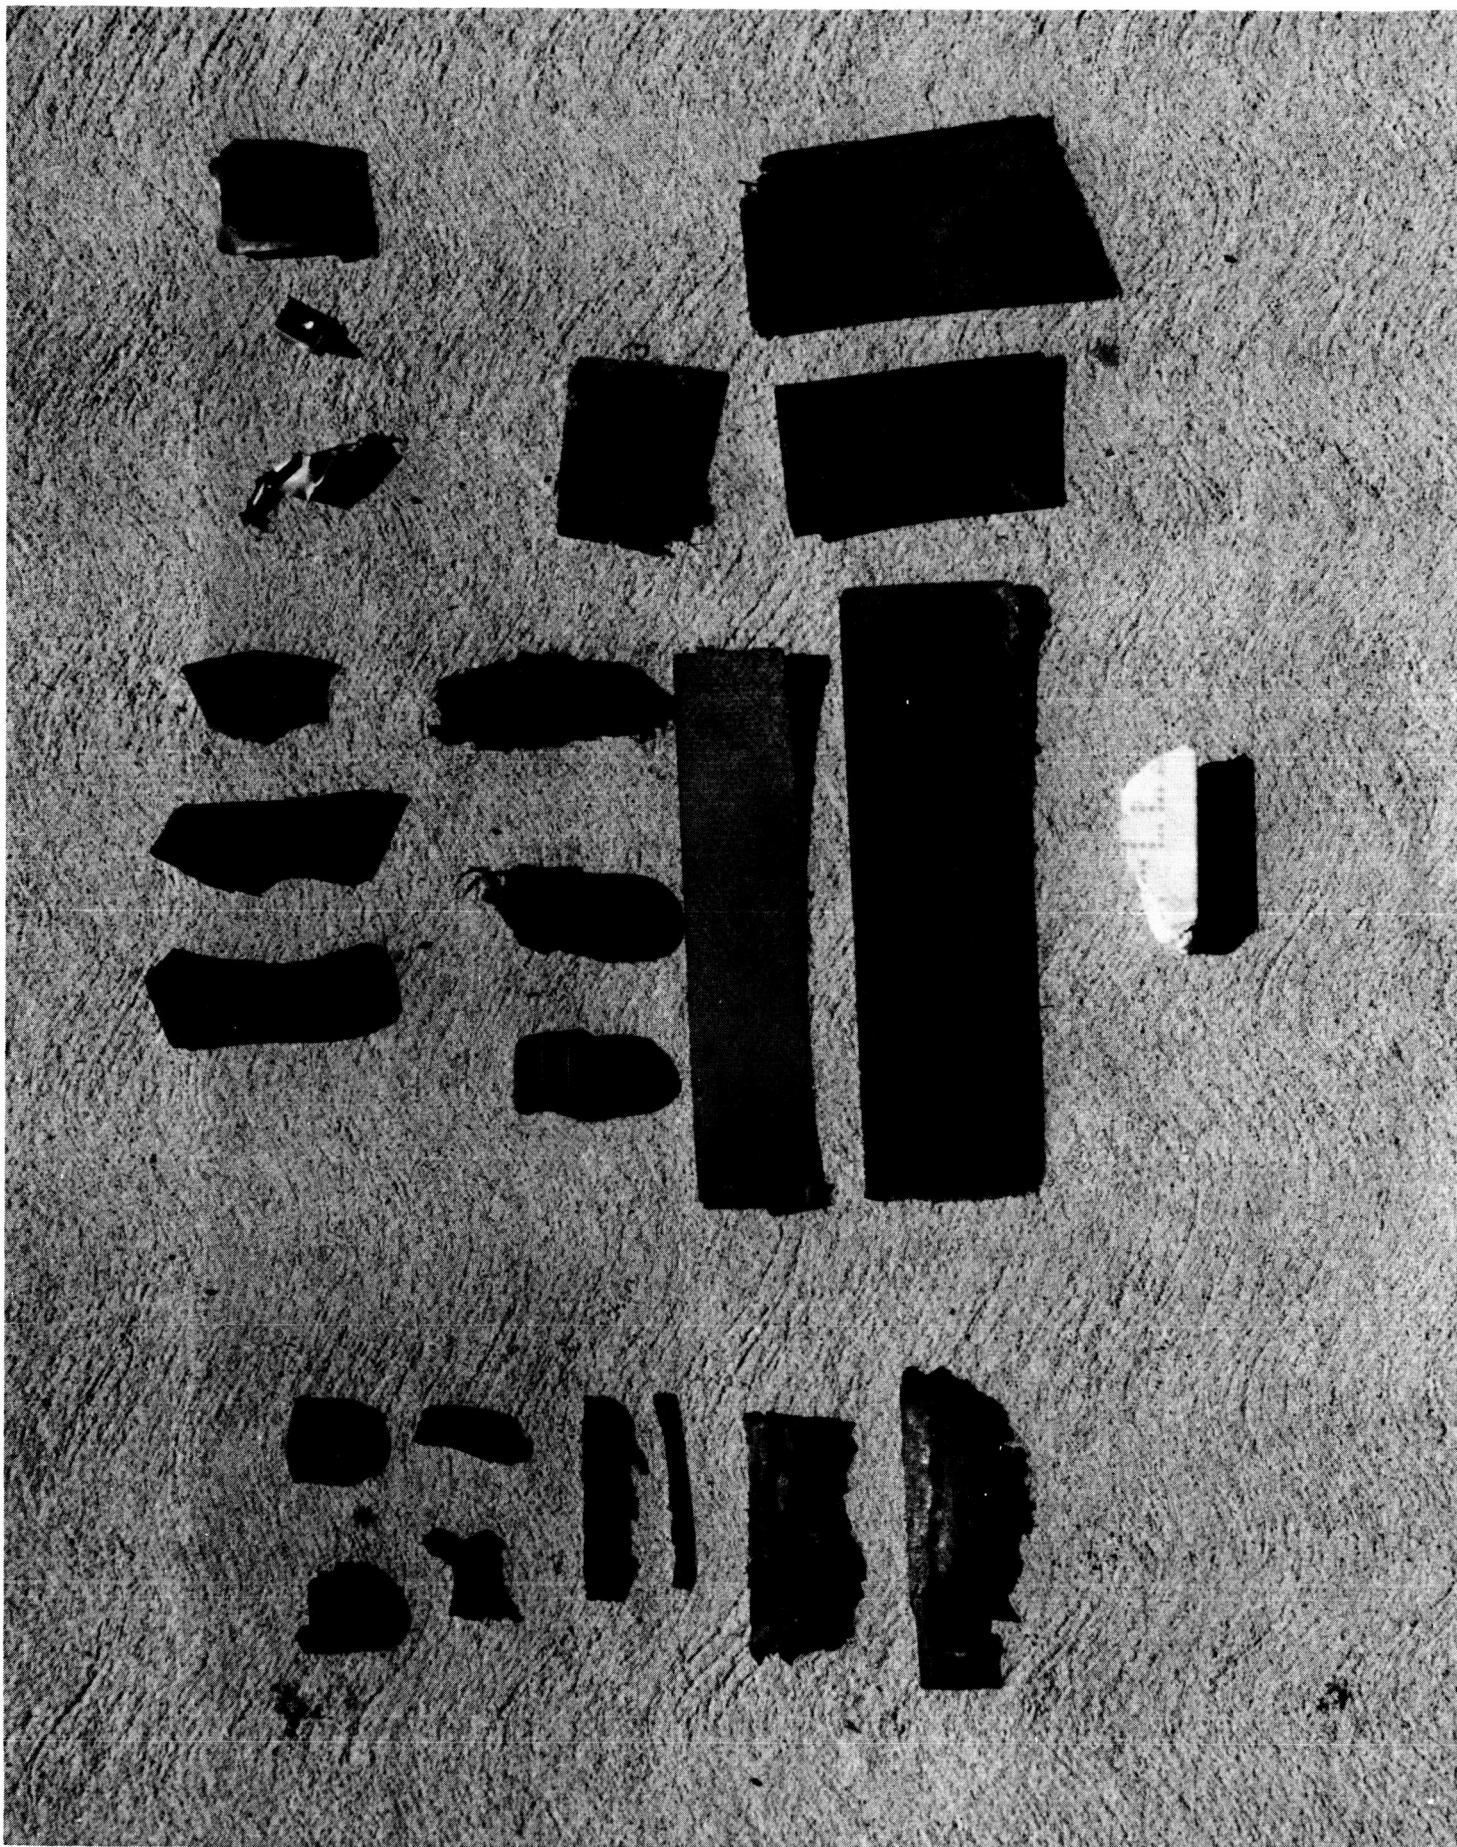
Post Launch Pad Inspection - flight hardware debris

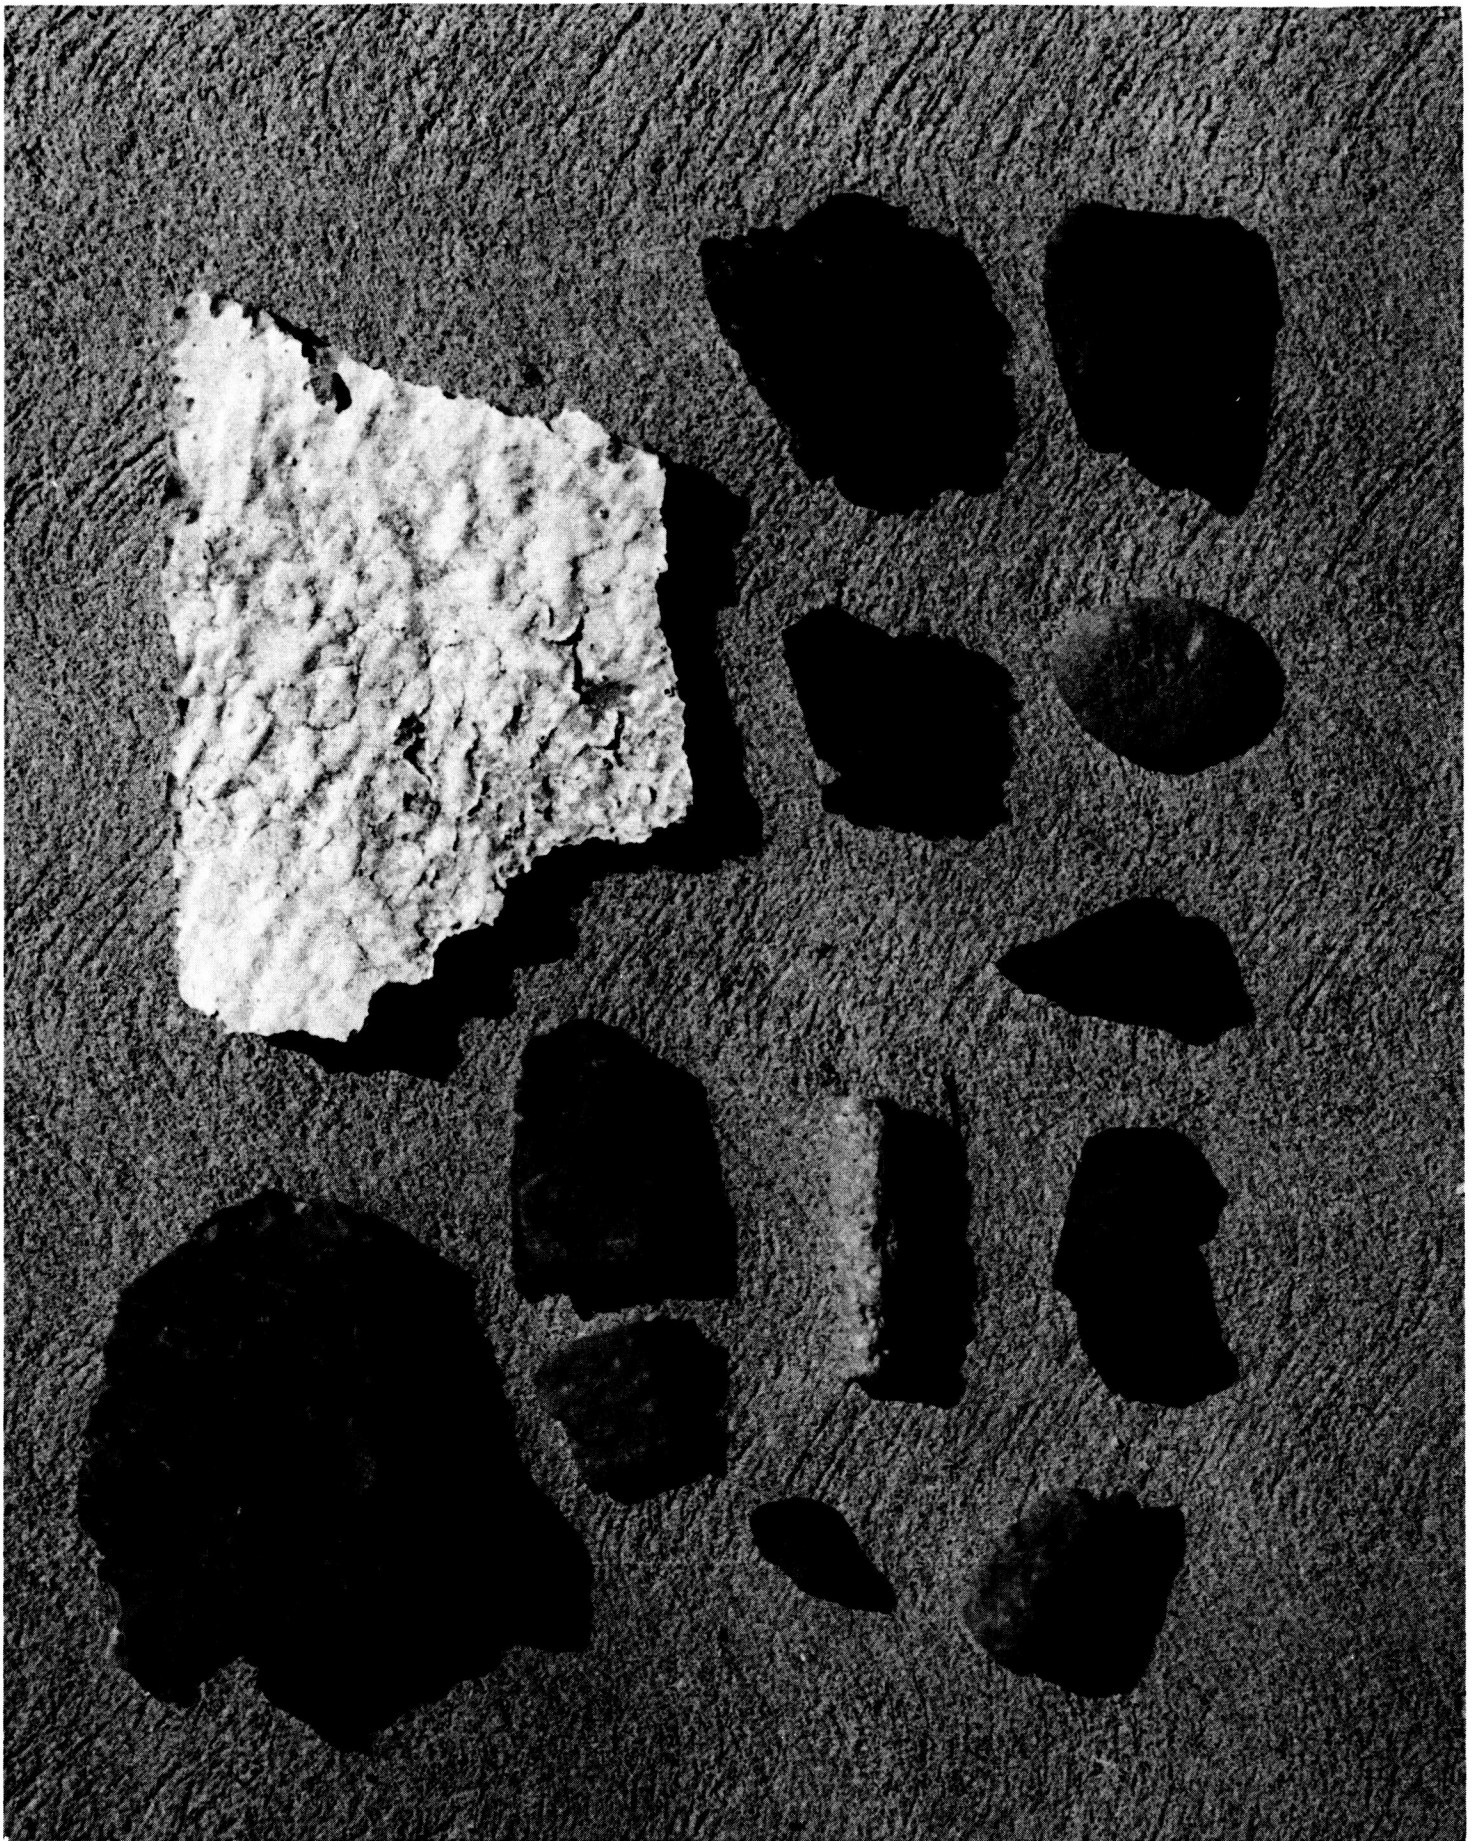
Five pieces of aged and weathered ET foam were discovered. The following table and map documents physical characteristics and location:

Post Launch Pad Inspection - foam and ablator samples

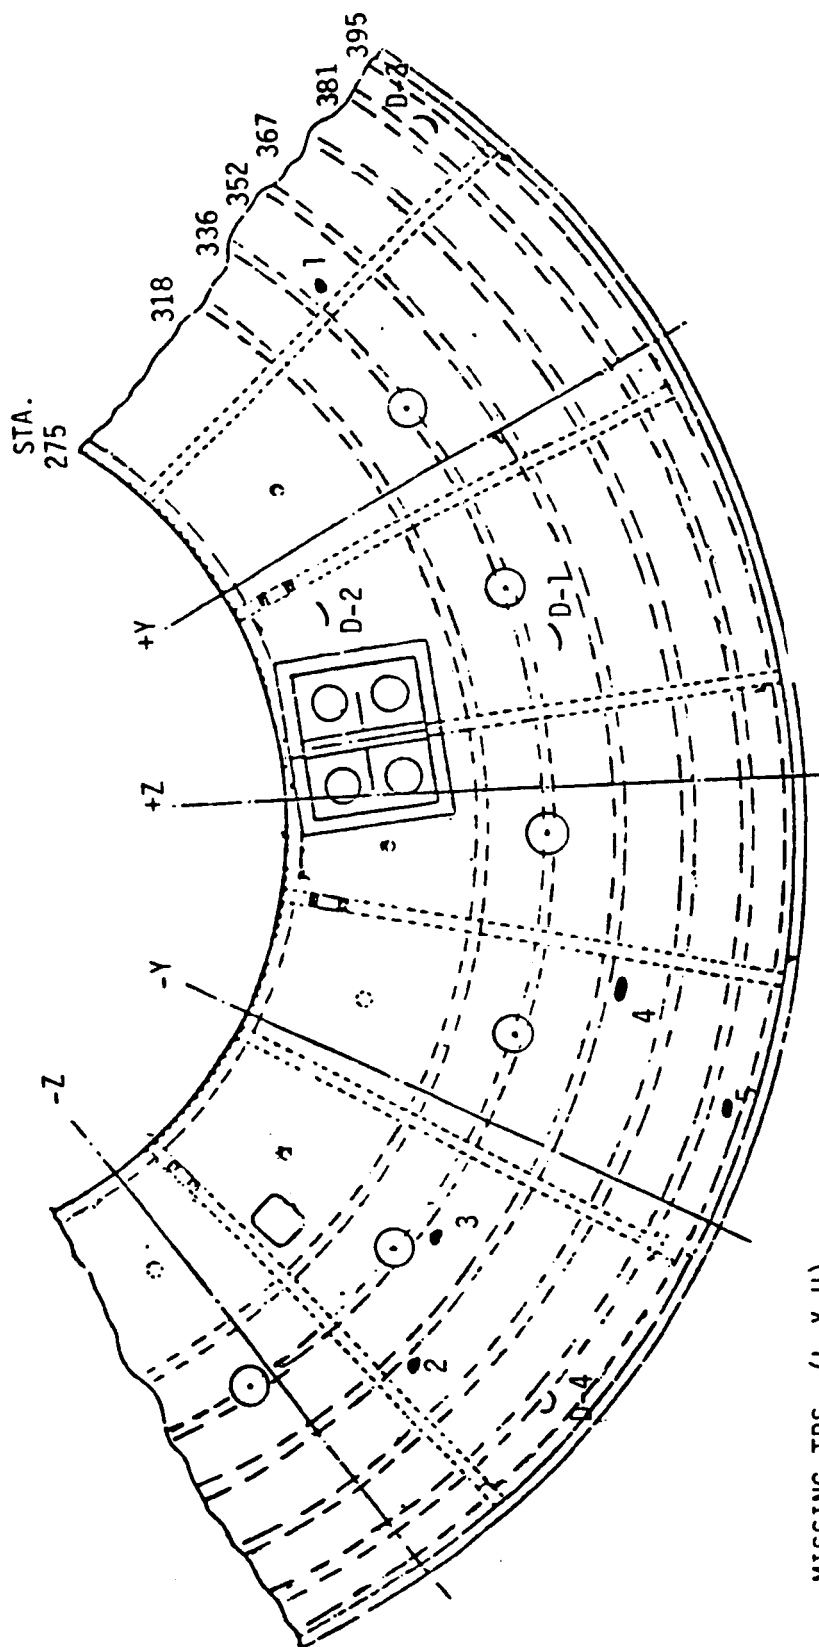
LEFT HAND FRUSTUM

MISSING TPS (L X H)

1. 3 X 1½
2. 3 X 2
3. 3 X 2
4. 3 X 2
5. 2½ X 1½

- D-1 ~ 2"
- D-2 ~ 2"
- D-3 ~ 3"
- D-4 ~ 2"

● APPROXIMATELY 1/2 CUP OF WATER IN SKIRT

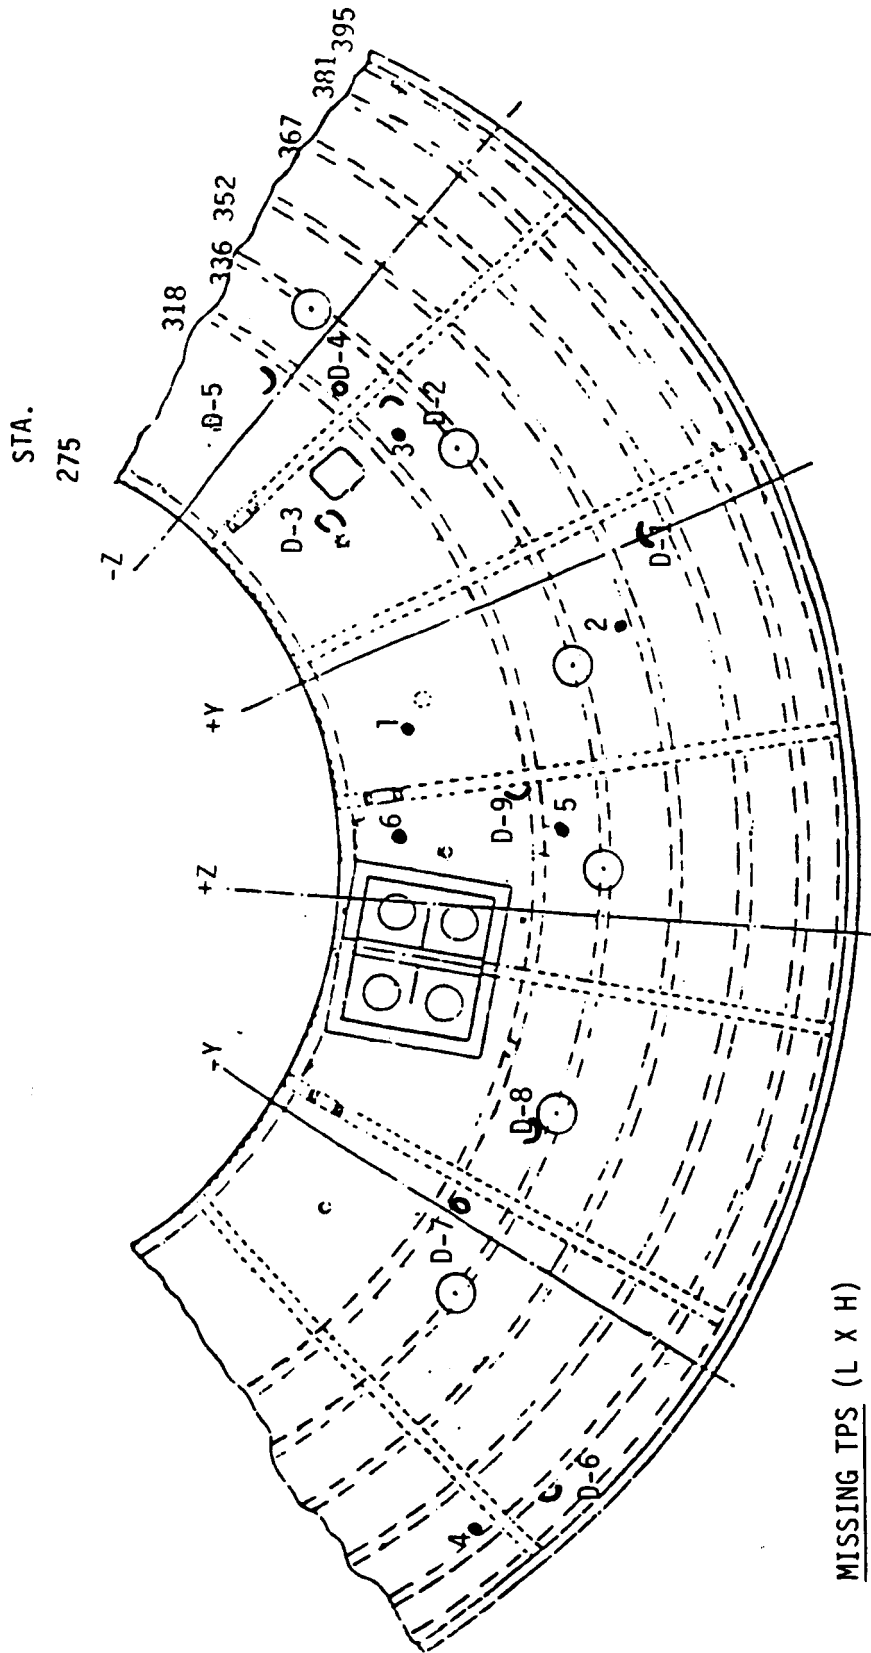
RIGHT HAND FRUSTUM

MISSING TPS (L X H)

1. 1" dia. *
2. 1 X 1/2 not to substrate
3. 1" dia. *
4. 2 X 2
5. 1" dia. *
6. 2 X 1

- D-1 ~ 2"
- D-2 ~ 1"
- D-3 ~ 4 X 2
- D-4 ~ 1" dia.
- D-5 ~ 1 1/2"
- D-6 ~ 2 1/2"
- D-7 ~ 1" dia.
- D-8 ~ 1"
- D-9 (1 1/2"

- APPROXIMATELY 1/2 CUP OF WATER IN CENTER OF SKIRT AND 1/2 CUP IN AREA NEXT TO AFT SEAL.
- ONE ORDNANCE RING PIN MISSING - APPROXIMATELY 5 PINS BACKED OUT SOME.

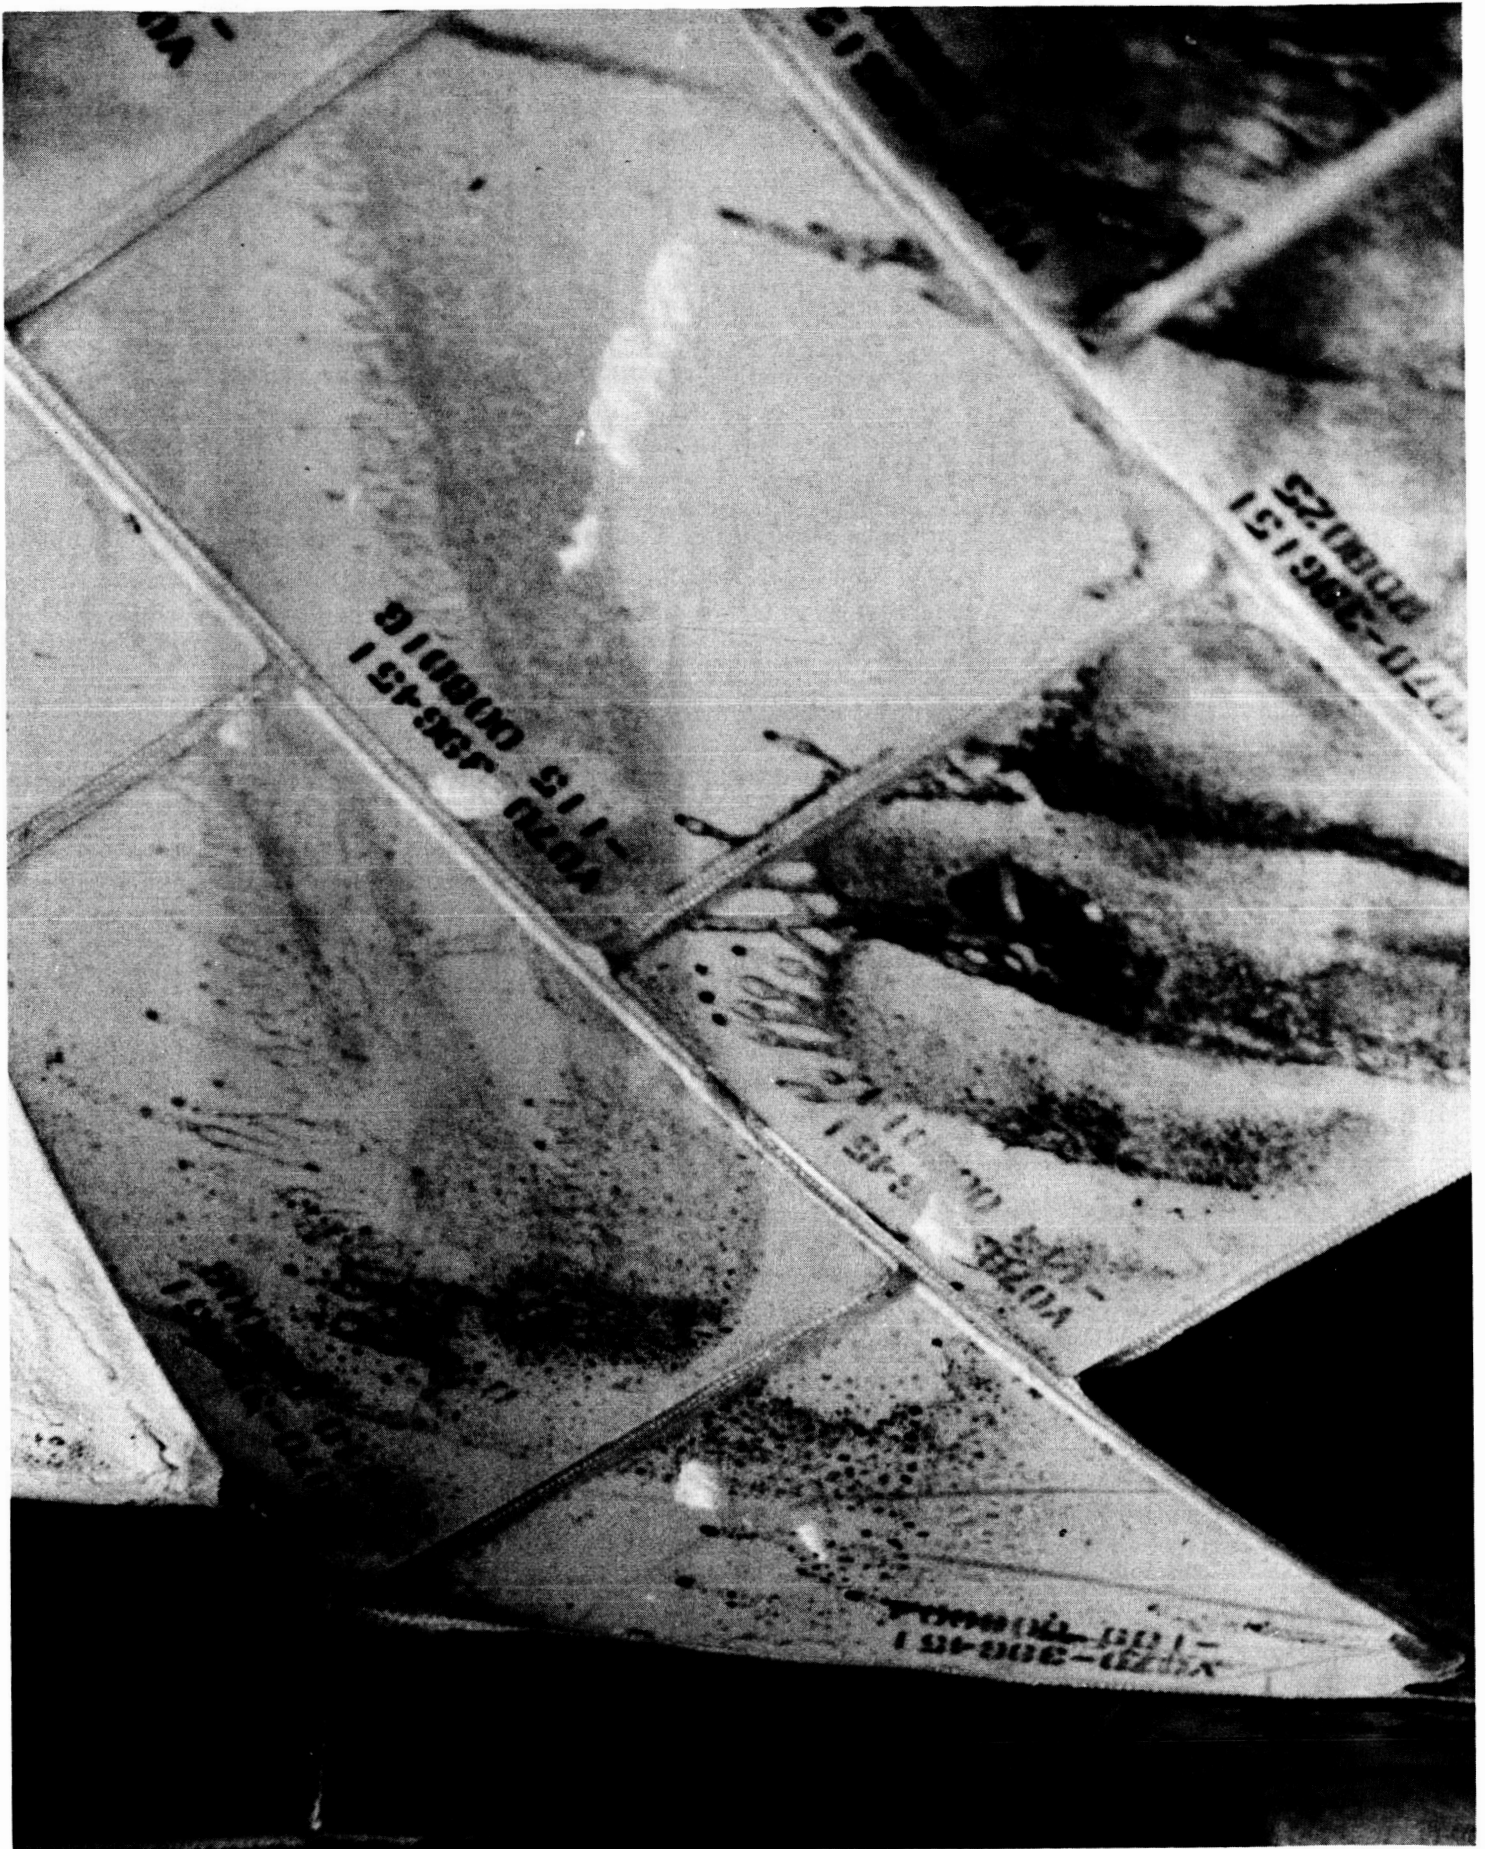
Typical OMS Pod tile damage

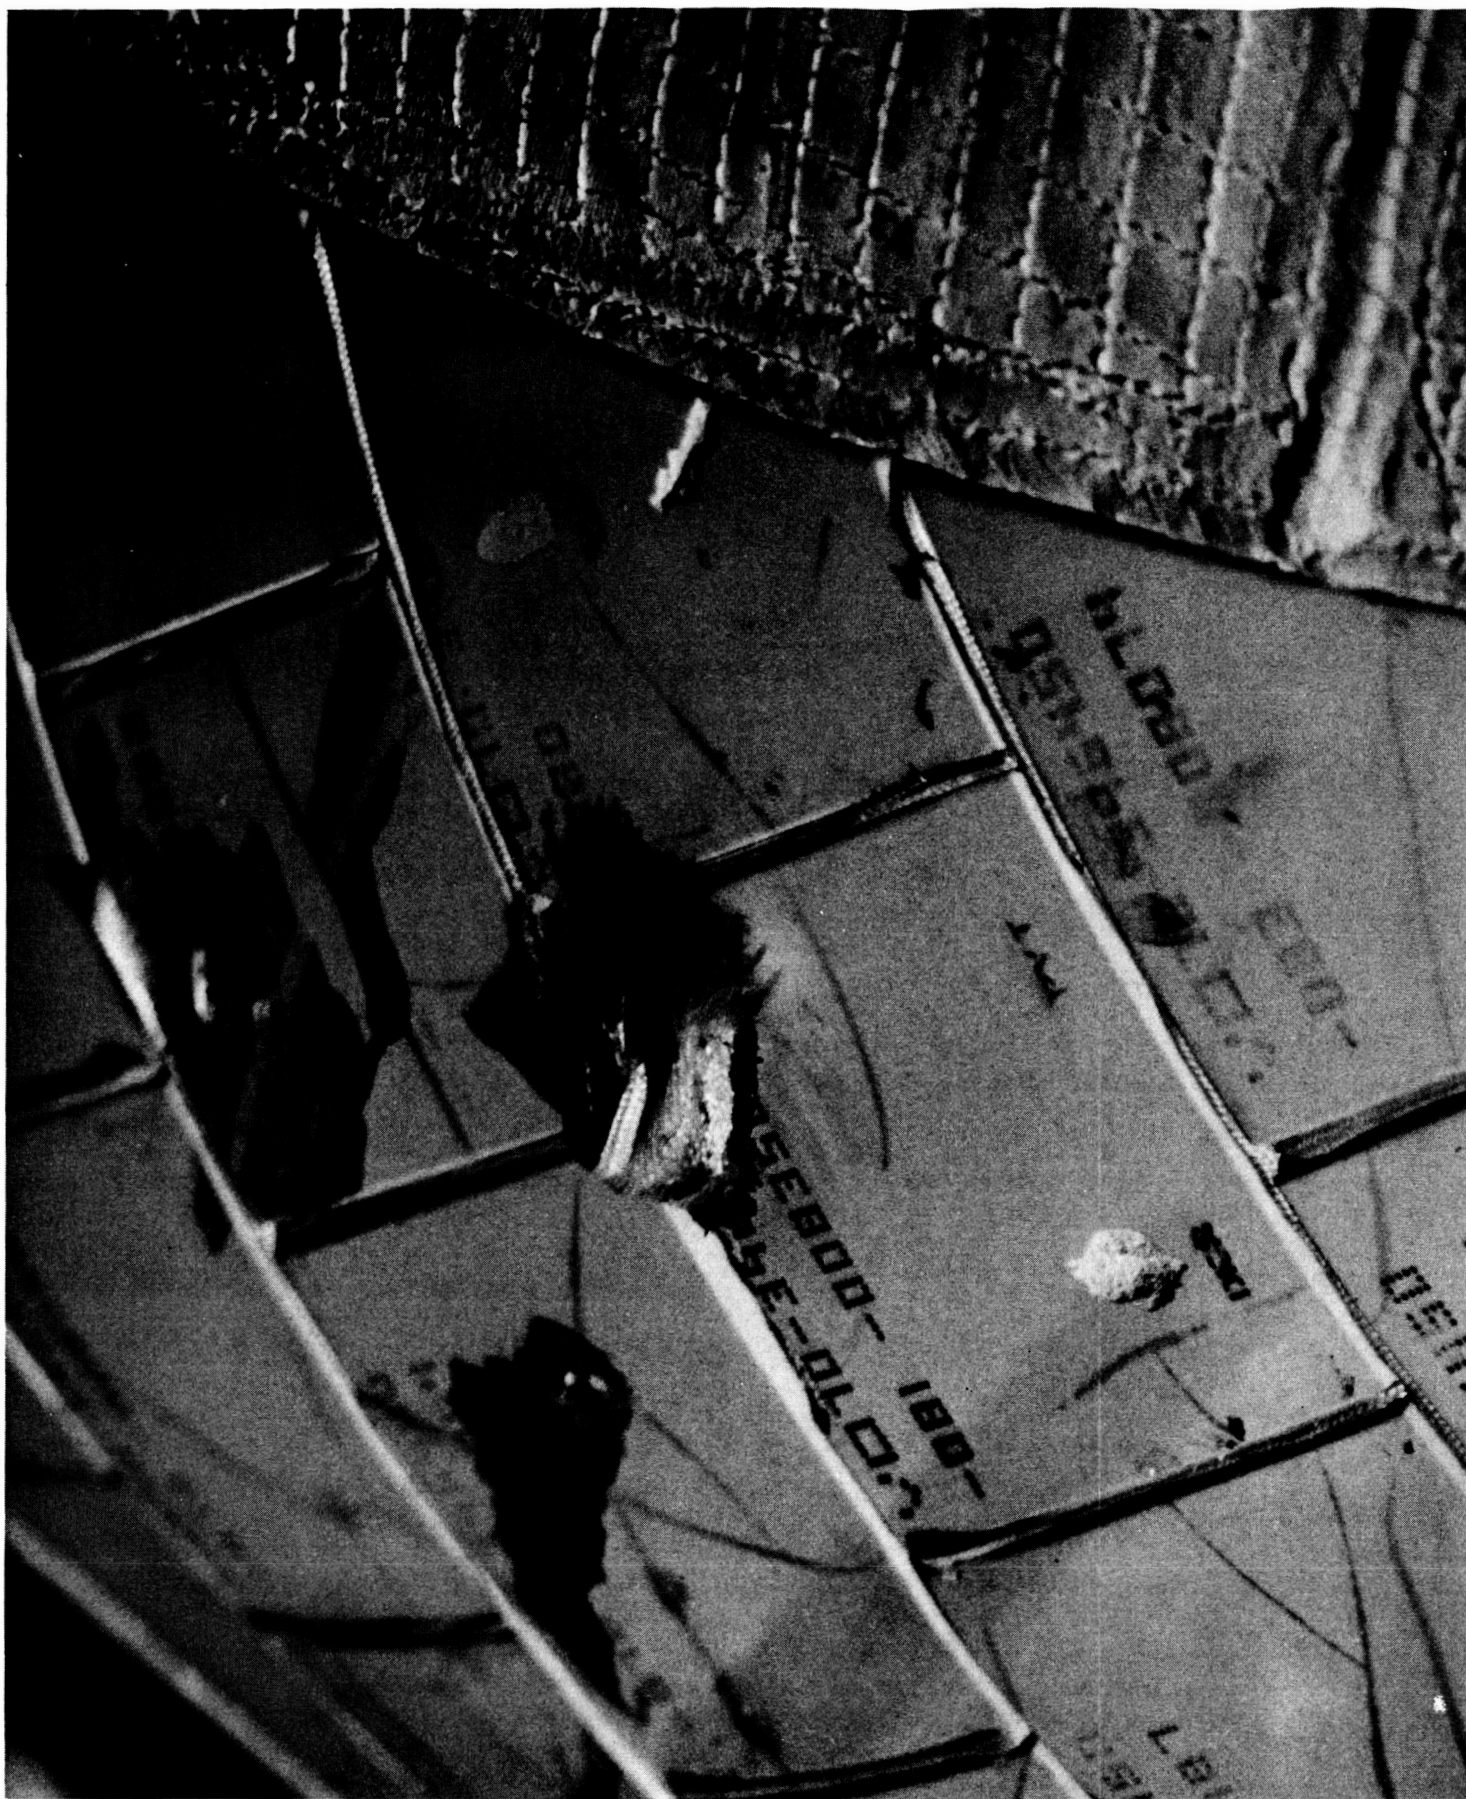
OMS Pod protruding gap filler

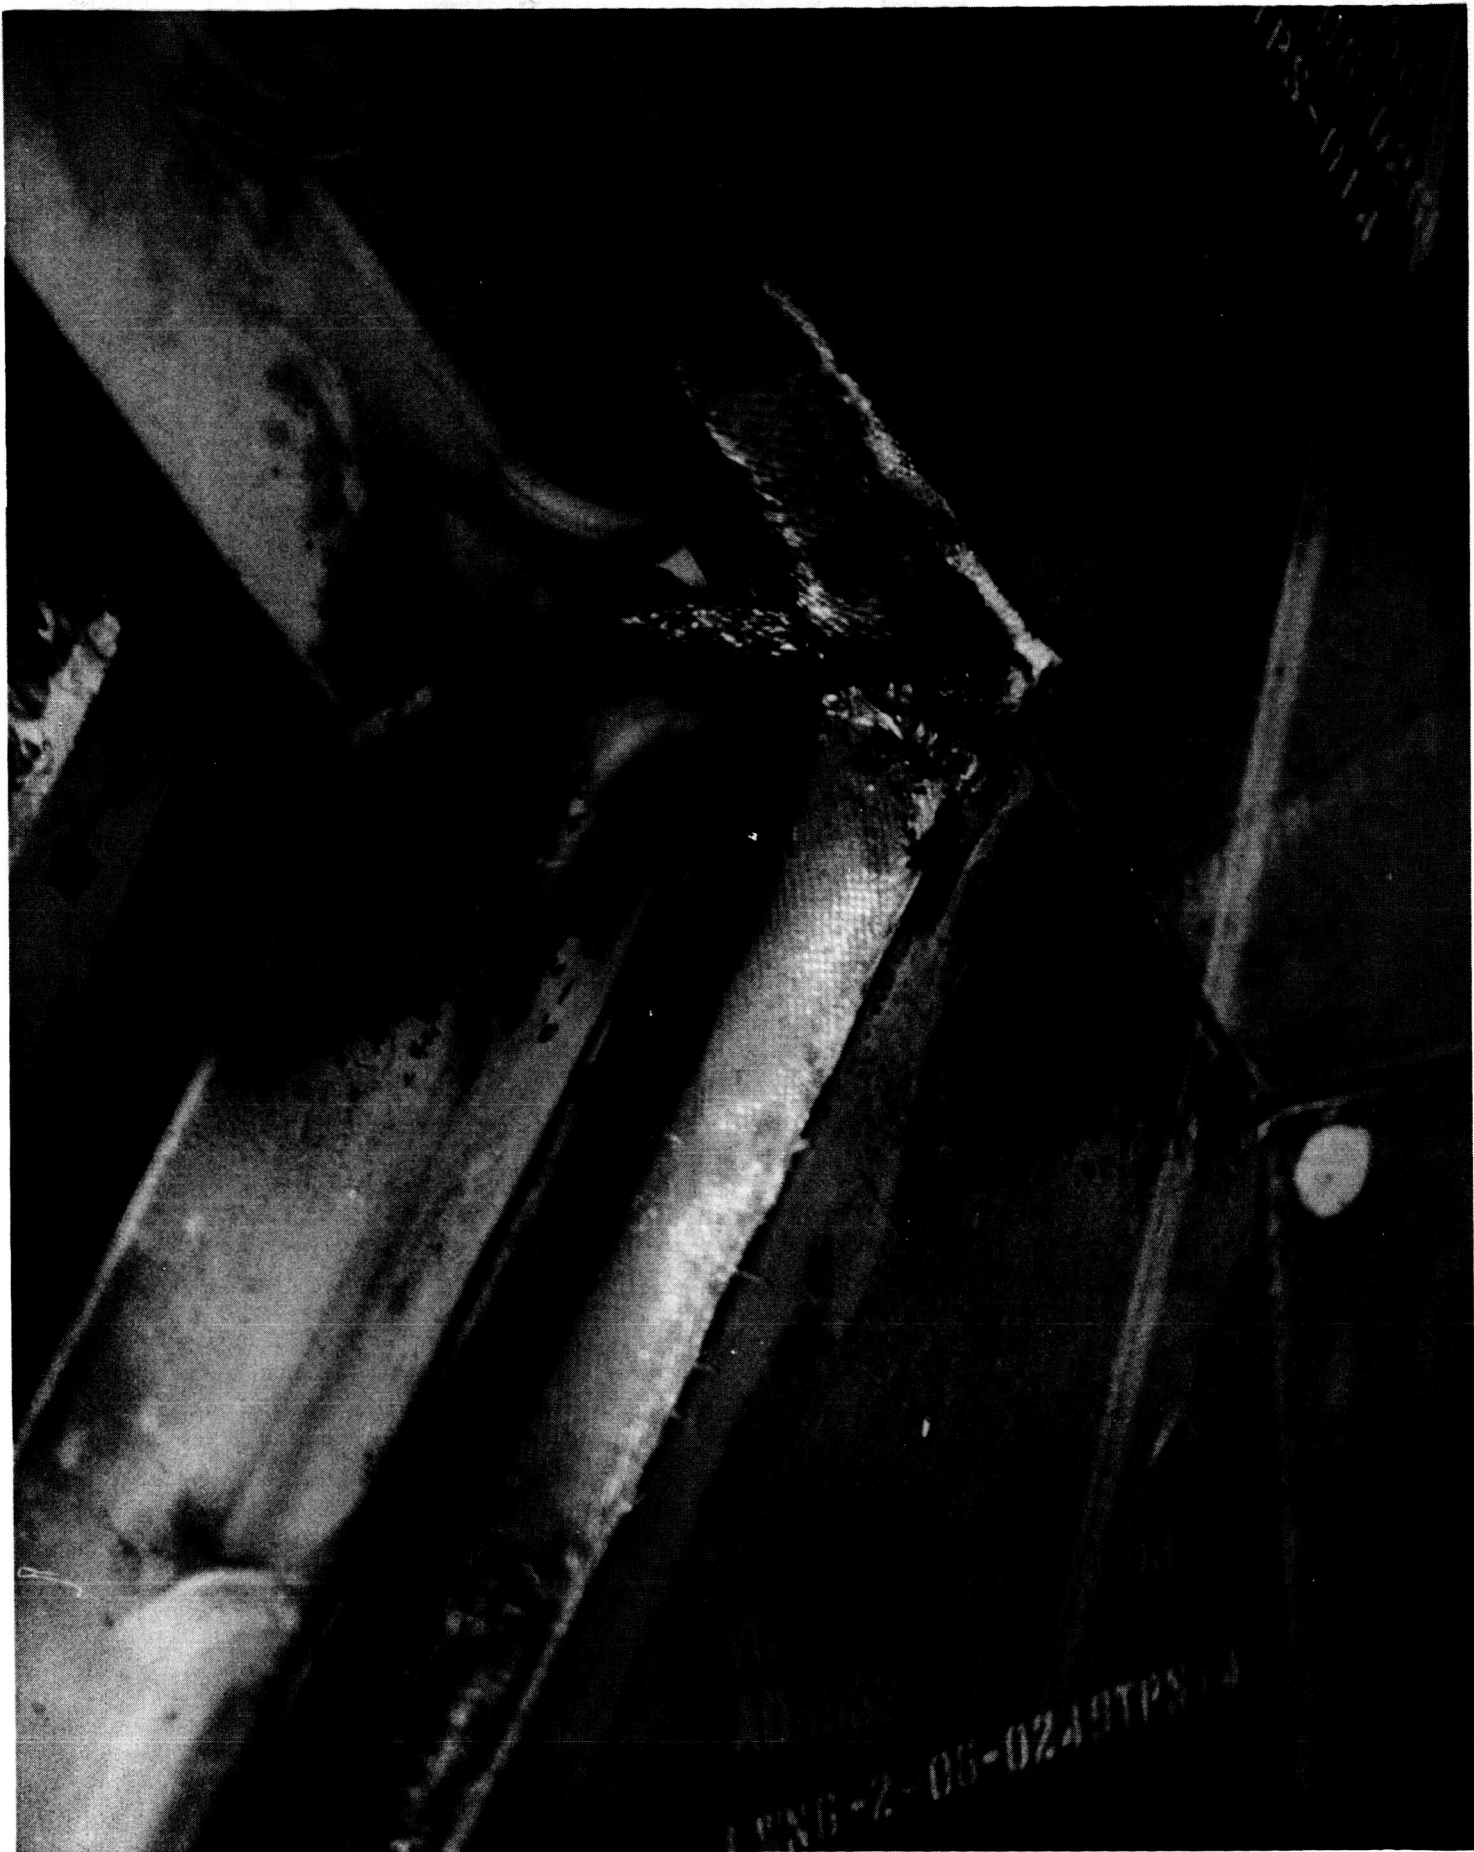
An inspection of the L02 ET/Orb umbilical well revealed a sedimentary deposit of coarse black powdery material is believed to be ET umbilical foam fire retardant coating. A 1x6 inch piece of the coating was also found. A piece of material (NSI assembly 3-1/2 x 1 inches) from the ET/Orb separation bolt was found loose up in the lower hinge mechanism. At separation, the nut prevented the plunger from falling into the bolt hole leaving an area for broken pieces to exit into the umbilical well area. Debris in the area of the hinge mechanism and tile moldline is a concern.

LO2 ET/ORB Umbilical well heat intrusion ORIGINAL PAGE IS
OF POOR QUALITY

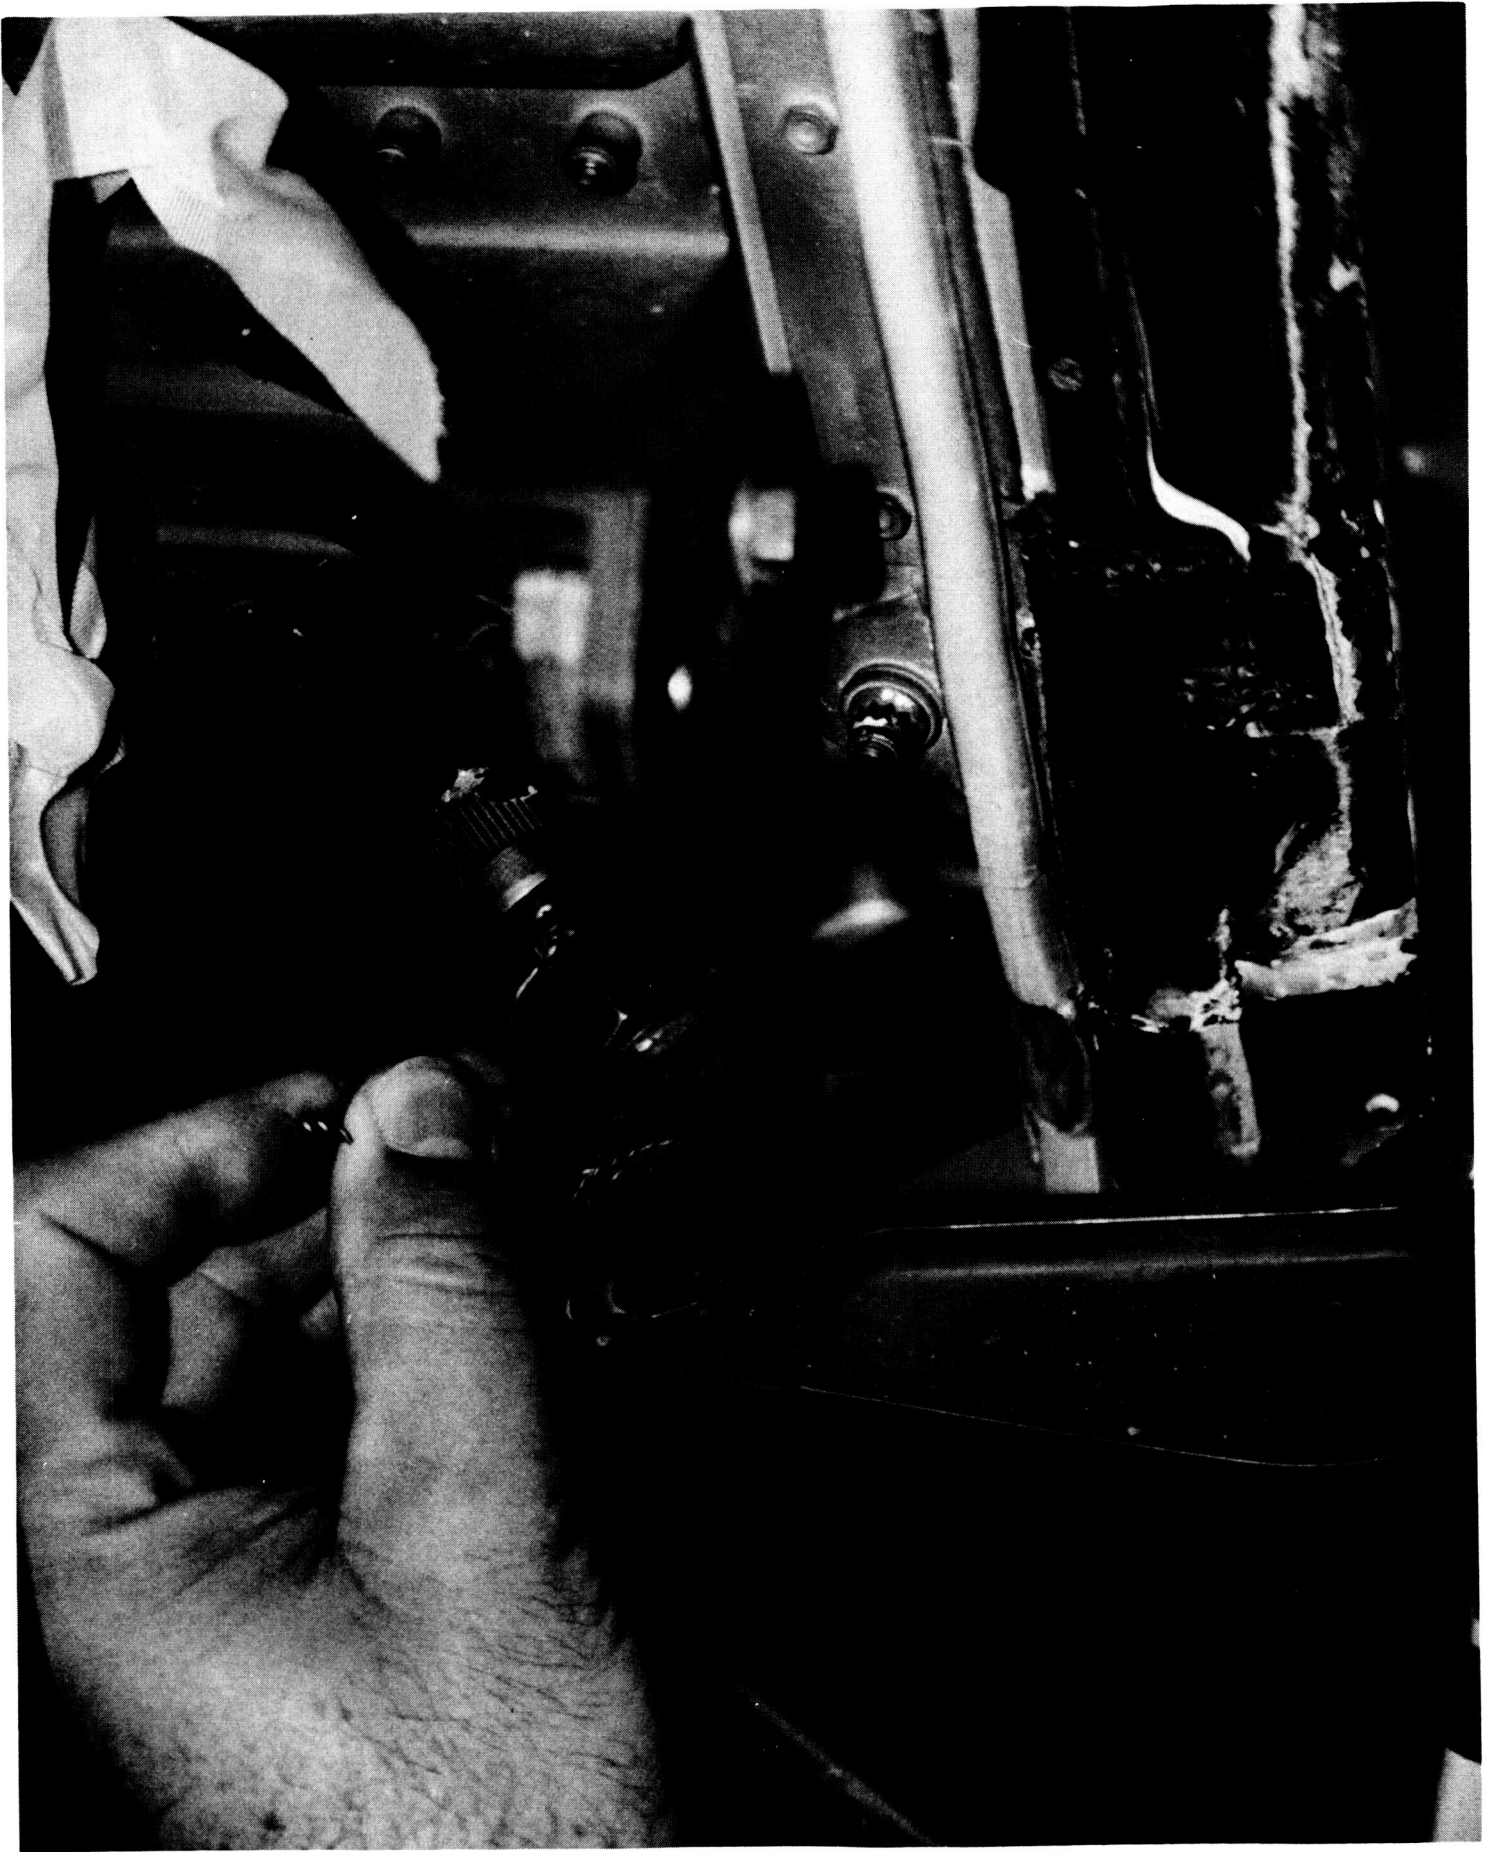
Loose NSI asseblly from ET/ORB Separation Bolt
